## **Failure Mechanism Analysis of 253MA Vortex Finder in A CFB Boiler Under High-Temperature Erosion and Refractory Deposit Exposure**

**Background:** Circulating fluidized bed (CFB) boilers are widely applied in coal-fired power plants due to their fuel flexibility and low emissions. The vortex finder, a key cyclone component, separates solid particles from flue gas and is prone to wear under high-temperature, erosive conditions. **Objective:** This study aims to identify failure characteristics, analyze the causes, and explain the failure mechanism of a 253MA vortex finder in a 2 × 100 MW CFB boiler at PLTU Sebalang after 6,548 operating hours at 850–950°C.

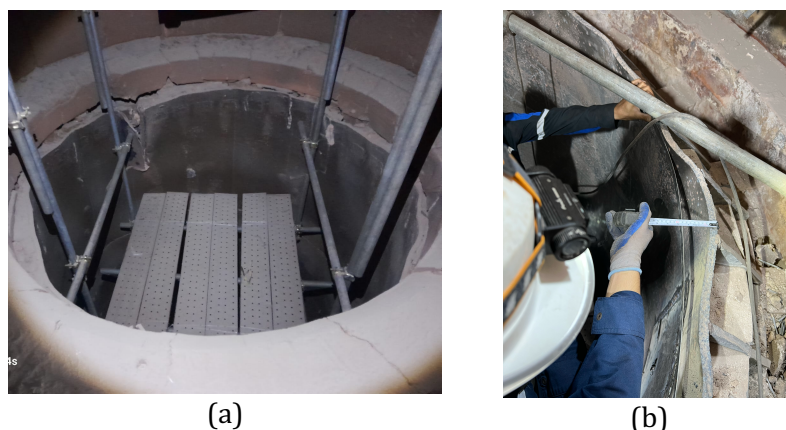
During the boiler inspection on January 13, 2025, indications of failure were found in the form of deformation at the end of the vortex finder, as shown in Figure 1. This material failure occurred in segment 1, or the uppermost segment of the vortex finder. During the visual inspection of the vortex finder surface, foreign material deposits were found, as shown in Figure 2, along with observable changes to the surface condition. This phenomenon indicates that the actual operating conditions inside the cyclone may still exceed the thermomechanical resistance limits of the material. Factors such as non-uniform temperature distribution, solid-particle impingement velocity, operating-load fluctuations, and chemical interactions between flue gas and the metal surface are suspected to be the main causes of degradation.

**Figure 1.** Vortex finder deformation during inspection: (a) vortex finder condition, (b) visual deformation check

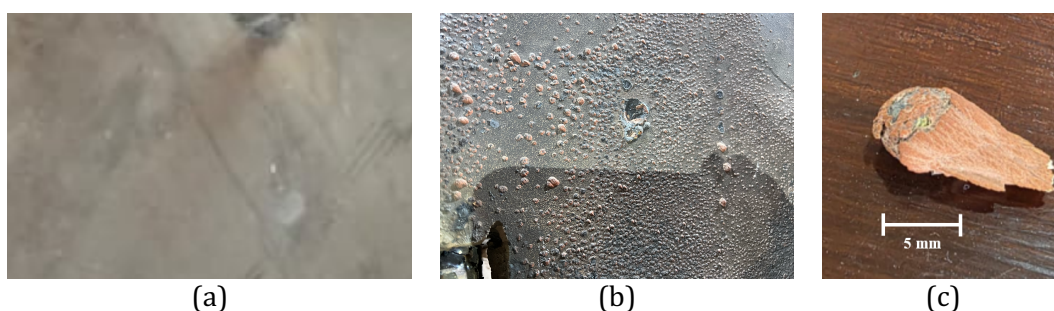
**Figure 2.** Comparison of (a) the vortex finder surface when first installed with (b) the surface after operation. (c) Foreign material found adhering to the vortex surface after operation

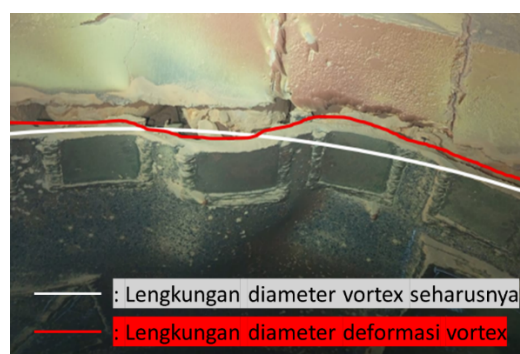
Figure 3 shows the vortex finder component that failed due to deformation. From Figure 3, it can be observed that the component geometry changed from its initial relatively flat configuration to an uneven and distorted form. This condition indicates that the material experienced plastic deformation during service operation, likely driven by combined effects of high-temperature erosion and refractory deposit exposure within the CFB environment.

**Figure 3.** Deformation on the Vortex Finder Surface

The furnace operating environment, which contains solid particles such as bed material and fly ash, has the potential to induce abrasive wear mechanisms on the material surface. This condition allows gradual material erosion, which may result in localized thickness reduction in the component. This localized thinning may increase stress concentration in certain areas, thereby initiating crack formation.

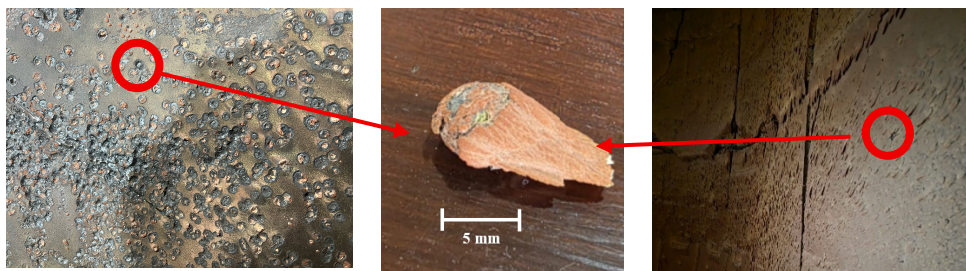
Figure 4 shows foreign particles adhering to the vortex finder surface. These deposits exhibit shapes and colors similar to those adhering to the refractory wall. The particles have irregular morphologies, relatively small sizes, and are distributed across several surface areas. The markings in the figure indicate the observed particle locations on the component surface, and samples of vortex finder material exposed to the foreign deposits were collected for further analysis.

**Figure 4.** Foreign Material on the Vortex Finder

The foreign material found adhering to the vortex finder surface exhibits visual characteristics similar to the refractory material on the cyclone wall, indicating that the particles originated from the refractory layer that was eroded by bed material and fly ash impacts during operation. The detached refractory particles were carried by the high-velocity hot gas flow and possessed sufficient kinetic energy to strike and adhere to the vortex finder surface. The presence of these hard particles intensifies the abrasion mechanism on the metal surface and accelerates material degradation, indicating that the cyclone operating environment not only exposes the component to high temperatures but also simultaneously imposes mechanical loading in the form of solid-particle impacts. Further characterization of the foreign material was conducted using XRD.

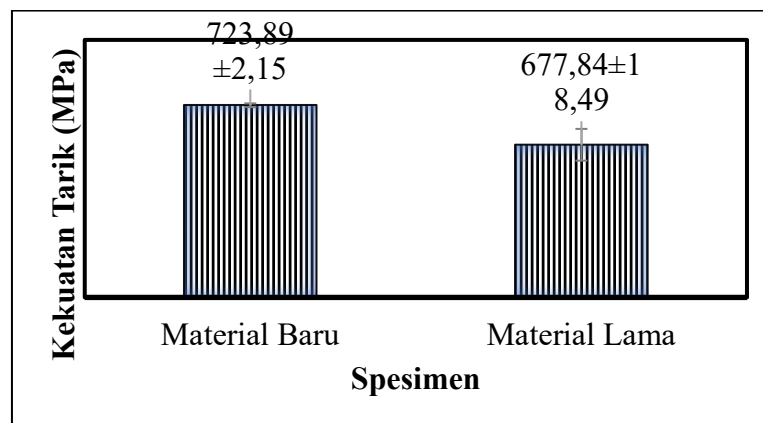
Figure 7 shows the tensile strength of the new and old materials. The new material had a tensile strength of 723.89 MPa, while the old material had a tensile strength of 677.84 MPa. The old material experienced a 6.36% decrease in tensile strength, attributed to thermal softening due to prolonged exposure to high operating temperatures. This softening is indicated by the enlargement of austenite grains, as discussed in the microstructural observation section. Softening due to temperature exposure is also confirmed by previous research ([Triasadian et al.](#),

Although the 6.36% decrease in tensile strength, the 8.62% decrease in elongation, and the 3.94% decrease in hardness are relatively modest in absolute terms, these changes are consistent with the expected mechanical property degradation patterns for austenitic stainless steels exposed to temperatures in the 850–950 °C range over extended periods. It should be noted that with only two specimens per condition, formal statistical significance testing is limited; however, the consistent directional trends across all three mechanical indicators (tensile strength, elongation, and hardness) provide converging evidence of genuine material degradation rather than random measurement variation.

**Figure 7.** Tensile Strength of New and Old Materials

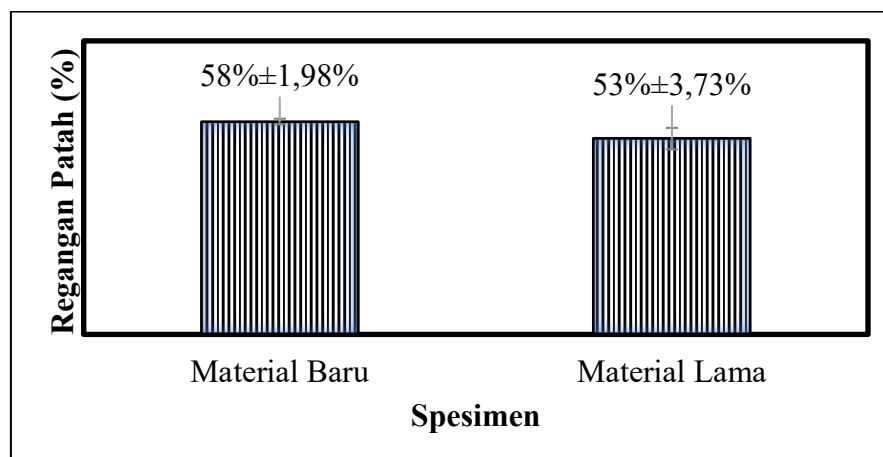
Figure 8 shows the fracture elongation values obtained from the test. The new material exhibits a relatively higher elongation at fracture compared to the old material. The old material experienced a 4.7% reduction in elongation. This indicates that the new material retains better plastic deformation capacity prior to fracture.

**Figure 8.** Fracture Elongation of New and Old Materials

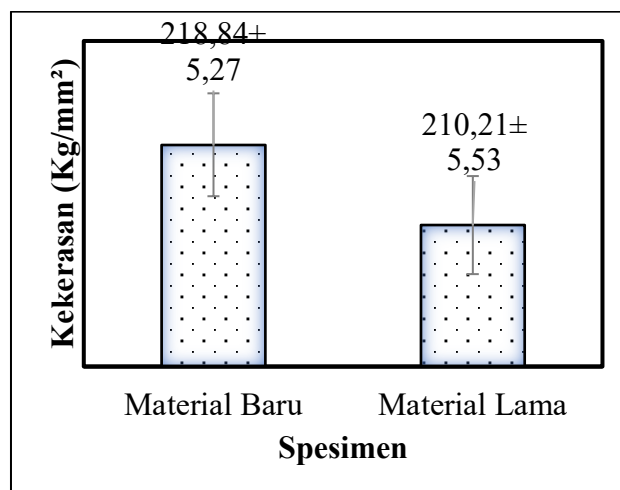
Figure 10 shows the microhardness test results. The results indicate that the new material had an average hardness value of 218.84 HV, while the used (service-exposed) material showed an average hardness value of 210.21 HV. The service-exposed material exhibited a 3.94% decrease in hardness compared with the new material. This difference indicates a measurable reduction in material hardness after exposure to operating conditions in the CFB boiler environment.

**Figure 10.** Hardness Test Results

The decrease in hardness indicates that the material underwent softening due to prolonged exposure to high temperatures. High operating temperatures can induce a recovery process in the crystal structure of the material, in which some dislocations are reduced or rearranged. This process can lower the hardness and strength of the material.

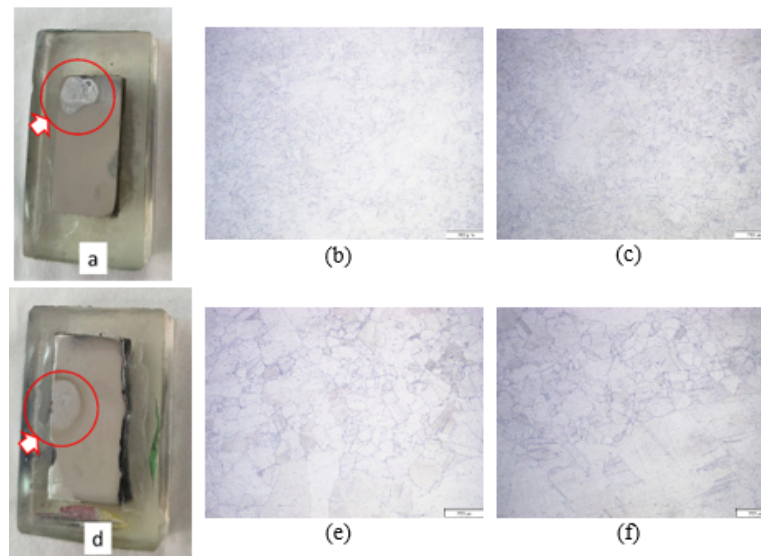
defined grain boundaries, without indications of plastic deformation or secondary recrystallization, reflecting an optimal microstructure with high strength and deformation resistance. Meanwhile, the used material (Figures e and f) shows grain coarsening with thickened and irregular grain boundaries, as well as indications of segregation along grain boundaries due to intensive atomic diffusion during long-term high-temperature exposure. These features indicate grain-boundary weakening and a potential reduction in mechanical properties.

**Figure 11.** Microstructural Test Results at 100x Magnification for New and Old Materials

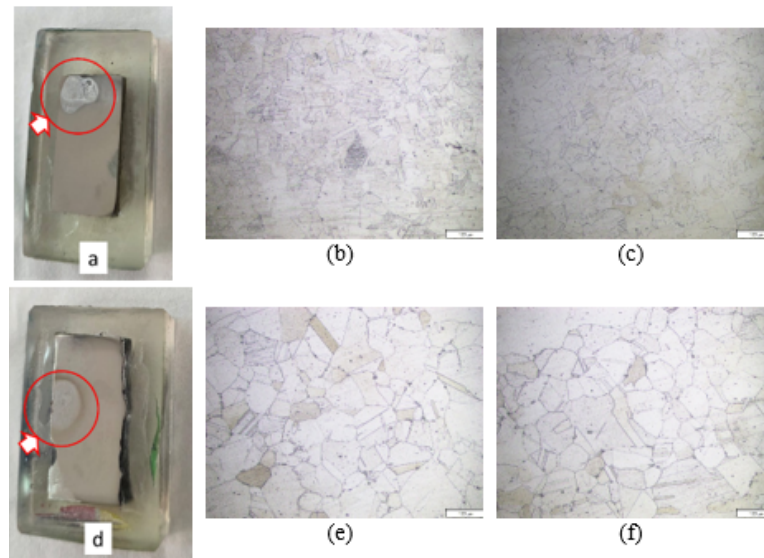
At 100× magnification, the new material showed a stable microstructure with fine, uniform grains and clear grain boundaries, without indications of deformation, while the old material exhibited grain coarsening, thickened and poorly defined grain boundaries, and grain distortion due to long-term high-temperature exposure, indicating a potential reduction in resistance to creep and cracking. Due to the limited resolution at 100× magnification, further observation was conducted at 200× magnification. Figure 12 shows the observation results at 200× magnification, where the new material (Figures a–c) exhibited fine and uniform grains with firm and clearly defined grain boundaries, indicating a low level of plastic deformation and the material's ability to maintain its initial strength in accordance with the Hall–Petch relationship. Meanwhile, the old material (Figures d–f) showed larger and irregular grains with widened and less well-defined grain boundaries, accompanied by indications of slip lines due to repeated mechanical stress. This condition reduces the number of effective grain boundaries, causing hardness and strength to decrease, although ductility tends to increase.

**Figure 12.** Microstructural Test Results At 200x Magnification for New and Old Materials

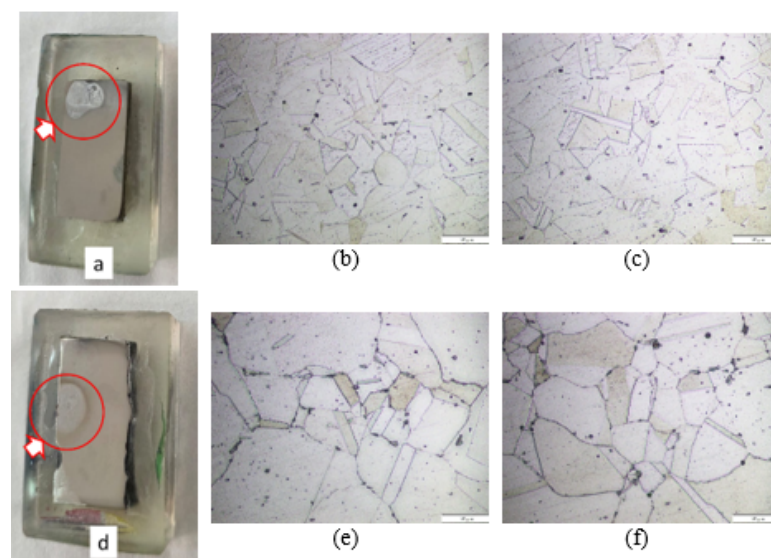
Comparison of the two conditions shows that the new material has finer grains with sharp grain boundaries, which correlate with higher mechanical strength, while the old material experienced microstructural degradation due to heating and service exposure. To strengthen the analysis, further observations were conducted at 500× magnification. Figure 13 shows the results at 500× magnification, where the new material (Figures b and c) exhibited fine, uniform, and equiaxed grains with thin, well-defined grain boundaries and minimal microdefects, indicating good structural integrity and high resistance to crack initiation. Meanwhile, the old material (Figures e and f) showed grain growth with larger, irregular, and elongated grains, accompanied by thickened grain boundaries, accumulation of secondary phases, and an increased number of microdefects in the form of voids and indications of microcracks along grain boundaries. This condition indicates that grain boundaries have become weakened regions due to stress concentration, reducing the material's ability to resist deformation and significantly increasing the potential for intergranular crack propagation.

**Figure 13.** Microstructural Test Results At 500x Magnification for New and Old Materials

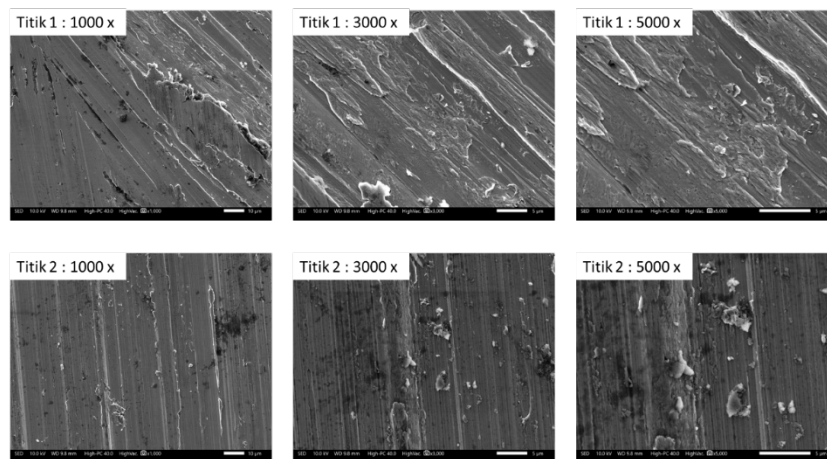
Figure 16 shows the Scanning Electron Microscopy (SEM) observation results for the old material. The surface morphology of the old material in Figure 5.14, which had been exposed to service conditions, showed a higher level of damage. Parallel-line patterns were still visible; however, they had become distorted, widened, and irregular, indicating plastic deformation due to frictional loading and operational pressure during service. Surface delamination, material build-up, and the formation of coarse particles adhering to and spreading unevenly were also observed. This phenomenon indicates the dominance of wear mechanisms such as adhesive wear and abrasive wear.

In addition, several areas showed early indications of microcracks and pits (small depressions), which could develop into crack initiation sites. The rougher and more heterogeneous surface indicates that the material experienced accumulated plastic deformation and possible long-term high-temperature exposure, which accelerated the degradation process.

**Figure 16.** SEM Results of Old Material

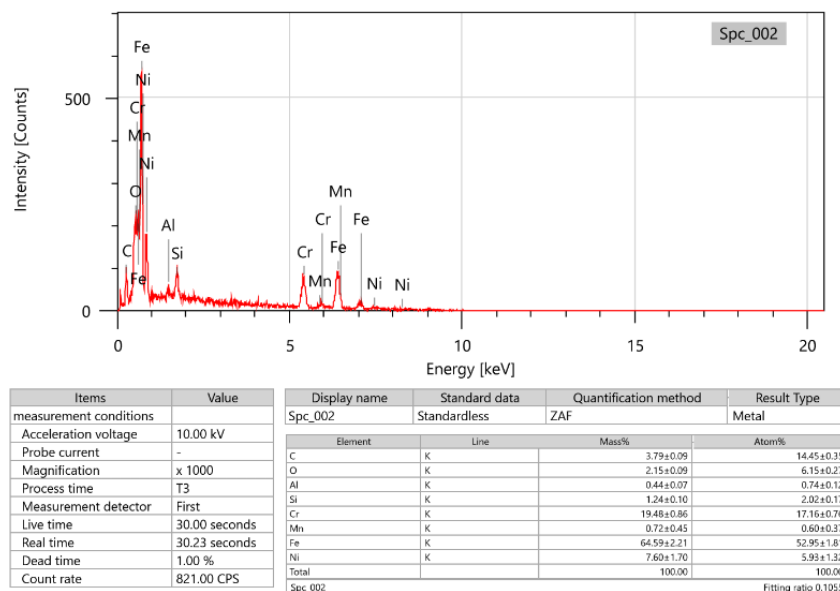
Figure 18 shows the EDS analysis results for the old material sample. The results indicate that the main elements composing the material were Fe, Cr, and Ni, with approximate contents of 64.59%, 19.48%, and 7.60%, respectively. These values indicate a slight decrease in Cr and Ni contents compared with those of the new material.

**Figure 18. SEM-EDS Test Results of Old Material**

EDS analysis of the old material showed a relative decrease in Cr and Ni content compared with the new material, indicating high-temperature oxidation effects, in which Cr reacts with oxygen to form a protective  $\text{Cr}_2\text{O}_3$  oxide layer, thereby reducing its measurable surface content. In addition, significant increases in Si (1.24%), Al (0.44%), and O (2.15%) were detected in the old material, indicating surface contamination due to interaction with  $\text{Al}_2\text{O}_3$ - and  $\text{SiO}_2$ -based refractory particles from the furnace operating environment, while also confirming ongoing high-temperature oxidation on the material surface. The presence of Si, Al, and O will subsequently be confirmed through XRD analysis.

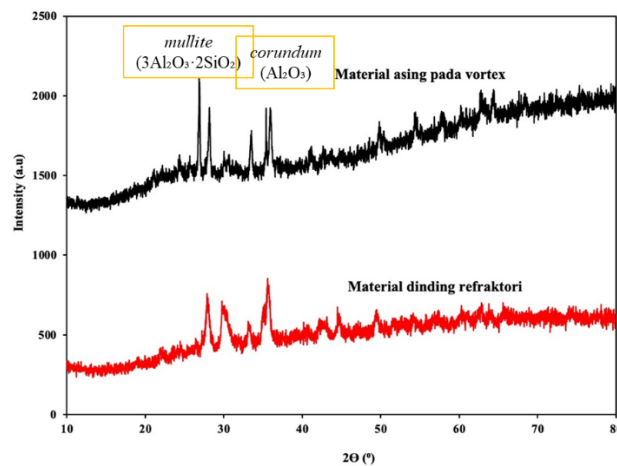
Figure 21 shows the XRD results for the foreign material adhering to the vortex finder and the refractory material. Qualitatively, the diffraction patterns in both graphs are almost identical. The obtained diffraction patterns show sharp peaks in the  $2\theta$  angle range from  $10^\circ$  to  $70^\circ$ , indicating that the material is dominated by crystalline phases. Based on matching with ICDD PDF database data, the dominant phase identified is mullite ( $3\text{Al}_2\text{O}_3 \cdot 2\text{SiO}_2$ ), indicated by characteristic peaks at approximately  $16.4^\circ$ ,  $25.9^\circ$ ,  $40.8^\circ$ , and  $60.1^\circ$ . In addition, a corundum ( $\text{Al}_2\text{O}_3$ ) phase was also detected at approximately  $35.1^\circ$ ,  $43.3^\circ$ , and  $57.5^\circ$ . The dominance of mullite and corundum is highly consistent with the chemical composition of the refractory material used, namely approximately 73%  $\text{Al}_2\text{O}_3$  and 23%  $\text{SiO}_2$ , where the combination of these two oxides thermodynamically forms mullite as a stable phase at high temperatures. Therefore, these XRD results confirm that the tested material is an alumina-silica-based refractory (high-alumina refractory) that conforms to the design specification (Hadining & Basuki, 2023).

**Figure 21.** XRD Results of Foreign Material and Refractory

The XRD results not only confirm that the foreign material adhering to the vortex finder is an alumina–silica-based refractory that meets the specification, but also indicate the influence of the operating environment on changes in the material structure. The combination of foreign material, amorphous phase formation, and localized hotspot conditions is a major factor contributing to microstructural changes in the vortex finder, which in the long term may develop into a material failure mechanism.
