## **Failure Analysis of High Pressure Shaft Pump Sea Water Reverse Osmosis in the Labuhan Angin Generation Business Unit**

Institut Teknologi Sepuluh  
Nopember,  
Indonesia

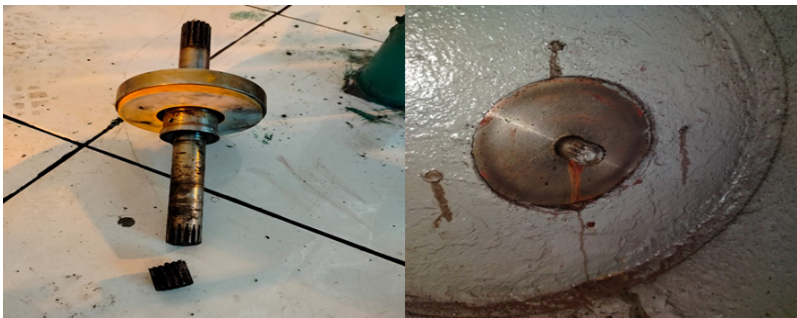
**Figure 3.** Shaft Fracture on HP Pump SWRO Date June 11, 2025 (Source: Private archive, 2025)

Before each shaft failure, the operational data showed similar characteristics: the coupling housing temperature exceeded 90 °C, and the motor current exceeded 295 A. Subsequently, the motor current suddenly decreased to below 60 A, accompanied by a low-pressure alarm and a substantial reduction in discharge flow. These conditions indicated an operating failure of the HP pump, which was subsequently confirmed by the discovery of a fractured shaft at the coupling.

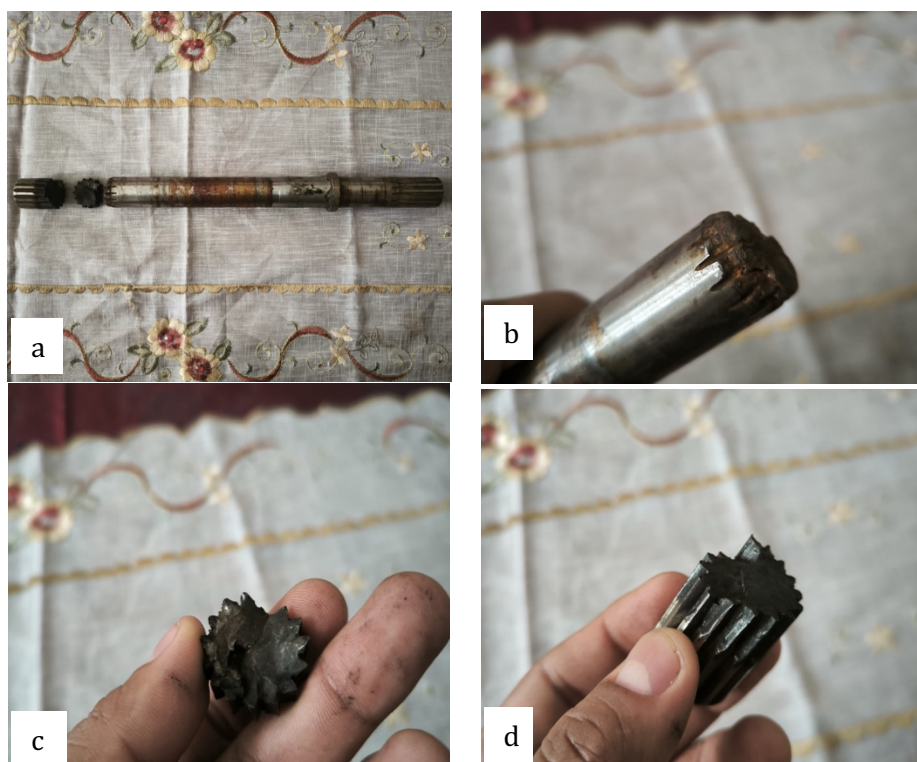
**Figure 6.** Failure Specimens: (a) HP Pump SWRO Test Specimen Experiencing Failure (b) Shaft as the Largest Part of the Fragment (c) Second Fragment on the Middle Side (d) Third Fragment as the End of the Shaft Coupled to the Pump Side

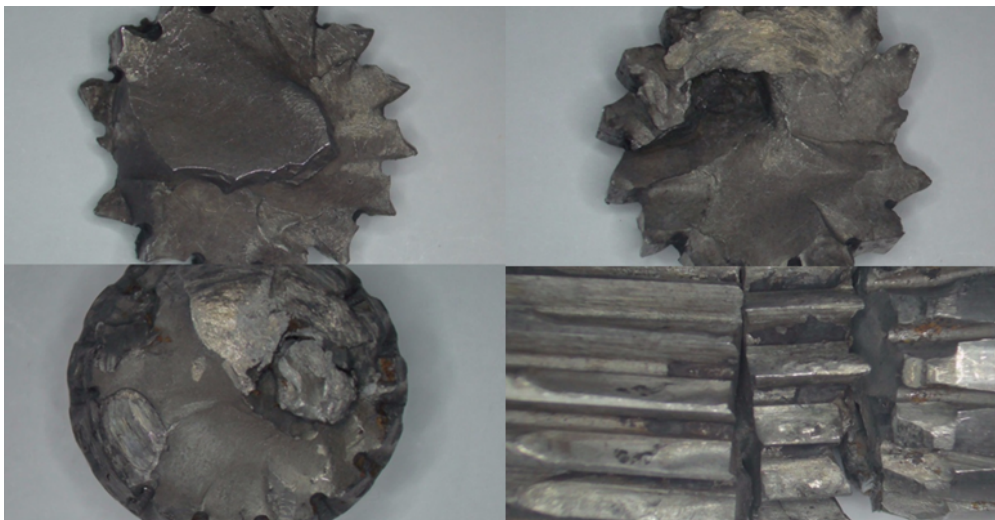
**Figure 7.** Macrostructure of Material A

As shown in Figures 7 and 8, the fracture patterns in both materials exhibit predominantly brittle characteristics, with little or no visible plastic deformation around the failure areas. The

pinion shaft gear sections appear relatively flat, and no necking is observed. In addition, rough line patterns are visible on the cross-sections of both materials. When these patterns are traced backward, they lead toward the respective crack-initiation areas.

The brittle fracture characteristics observed in both materials, including the absence of significant plastic deformation, relatively flat fracture surfaces, and the absence of necking, indicate that the final fracture occurred with limited macroscopic plastic deformation. These characteristics are consistent with the behavior of hardened martensitic stainless steel, which generally exhibits high hardness and strength but can have reduced toughness depending on its heat-treatment condition. The rough line patterns observed on the cross-sections and their apparent convergence toward the crack-initiation areas suggest that the fractures originated at localized stress-concentration sites and subsequently propagated through the material. The observed fracture features are consistent with a fatigue-failure mechanism that progressed toward a final rapid fracture after the crack had reached a critical size.

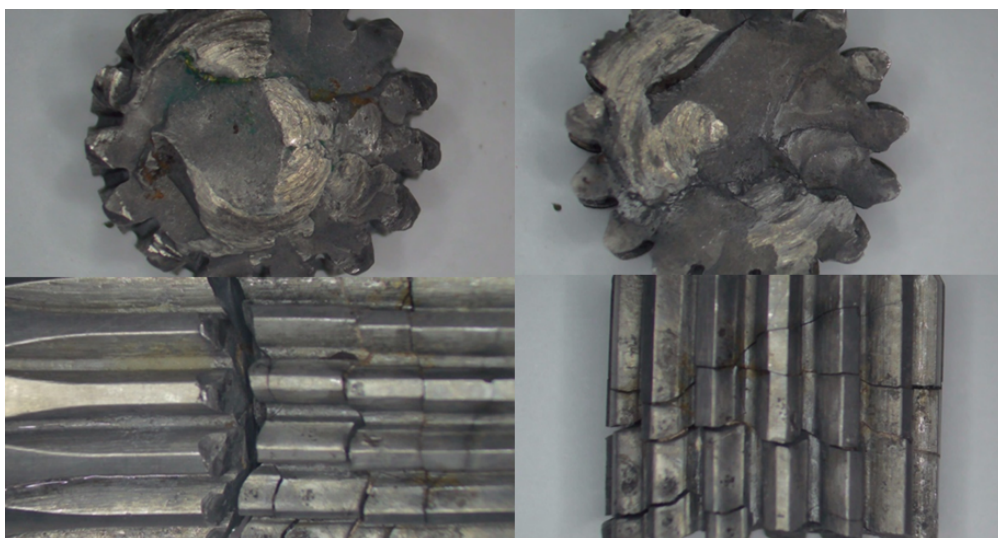
**Figure 8.** Macrostructure of Material B

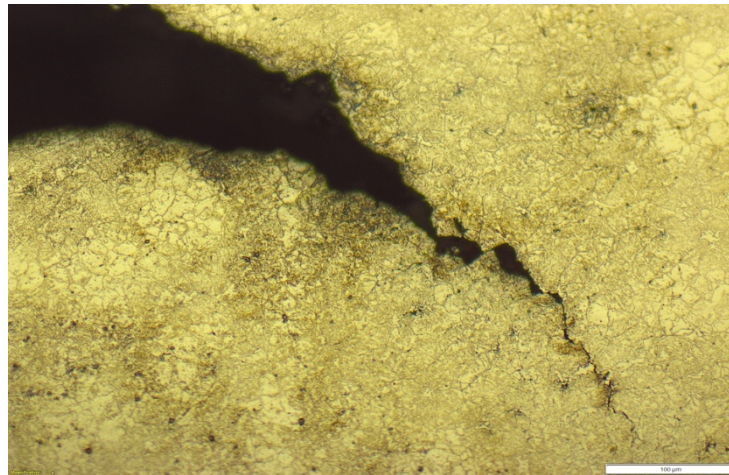
**Figure 9.** Imaging of Material Microstructure A

In Material A (Figure 9), the crack-propagation path is clearly visible through the grains, indicating a transgranular fracture mode. In contrast, Material B (Figure 10) exhibits microcrack propagation that predominantly follows the grain boundaries, indicating an intergranular fracture mode.

The differences in crack-propagation patterns between the two materials provide important information regarding their respective fracture mechanisms. In Material A, the transgranular propagation pattern indicates that the crack propagated through the crystal grains. This fracture mode can occur under cyclic loading conditions, particularly when the grain boundaries provide greater resistance to crack propagation than the grain interiors. Consequently, the crack may preferentially propagate through the grains.

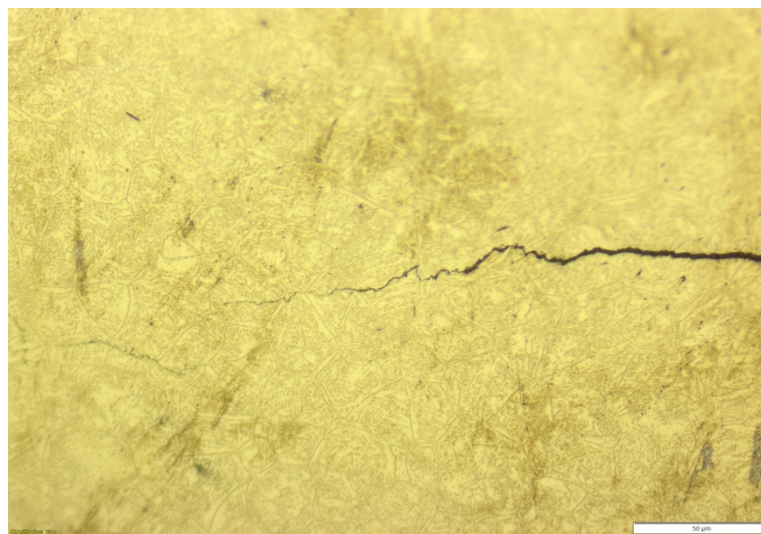
**Figure 10.** Microstructure Image of Material B

In contrast, the intergranular fracture pattern observed in Material B indicates that the grain boundaries acted as preferential paths for crack propagation. This phenomenon can occur because of impurity segregation at grain boundaries, excessive carbide precipitation along the grain boundaries, or corrosion-related degradation that reduces grain-boundary cohesion. In martensitic stainless steels, excessive or continuous carbide precipitation can also deplete chromium from the surrounding matrix, potentially reducing local corrosion resistance and promoting intergranular corrosion or sensitization. These differences in fracture mechanisms are important because each mechanism requires a different preventive and corrective approach.

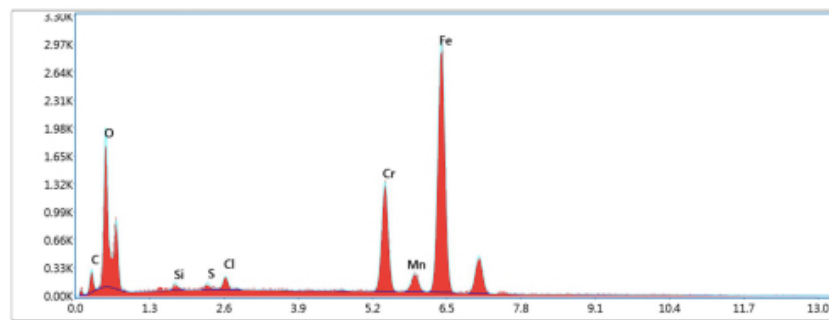
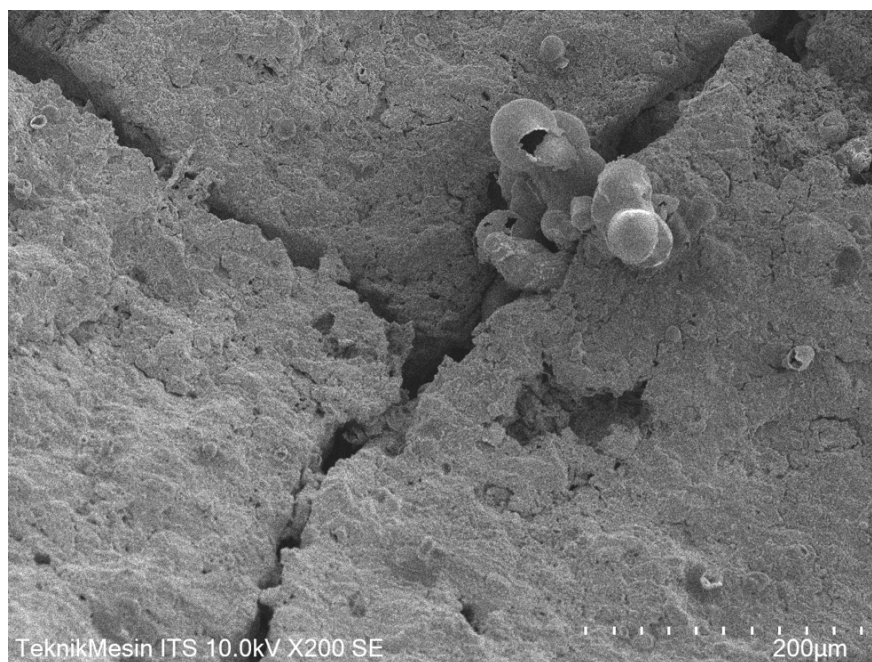
**Figure 11.** Content Spectrum in Material Fracture Area A

**Figure 12.** Appearance of Chromium Carbide Precipitate in Material A

In Material A, chromium carbide precipitates are observed, as shown in Figures 11 and 12. In Material B, chromium carbide precipitates are also indicated by the EDS results obtained from the fracture area (Figure 13). Meanwhile, the SEM image of Material B (Figure 14) clearly shows characteristics of brittle fracture, accompanied by microvoids and localized porosity on the fracture surface.

Carbide precipitation can occur during heat treatment and subsequent cooling processes and can significantly influence the mechanical and corrosion properties of stainless steel. The presence of chromium carbide precipitates in both materials indicates that carbide precipitation occurred during processing. The size, morphology, and distribution of these precipitates strongly influence the mechanical properties of the material. Finely dispersed and appropriately distributed precipitates can contribute to strengthening, whereas excessive coarsening or nonuniform distribution can reduce the effectiveness of precipitation strengthening (Lee et al., 2023). Excessive chromium carbide precipitation along grain boundaries can also reduce the chromium concentration in the adjacent matrix, thereby decreasing localized corrosion resistance and potentially promoting sensitization and intergranular corrosion.

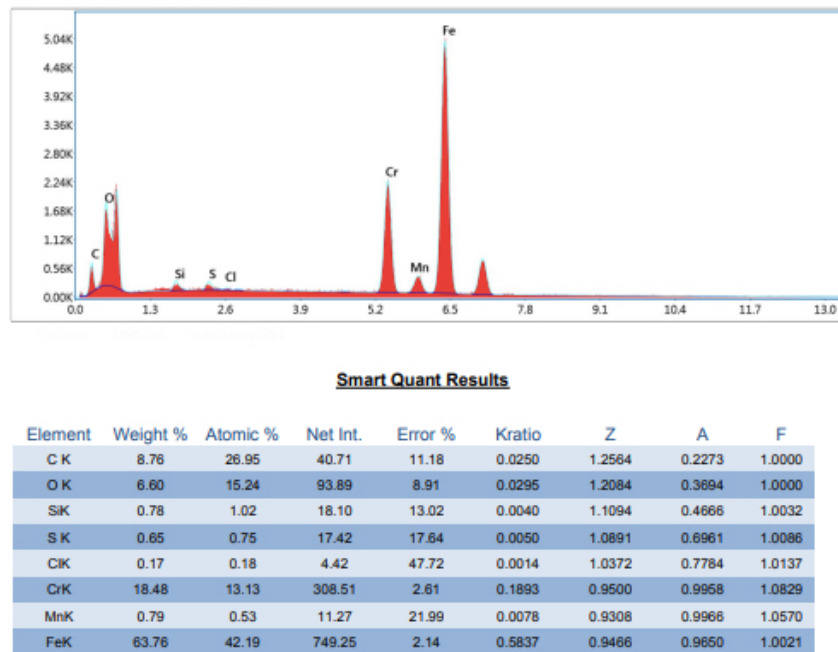
**Figure 13.** Content Spectrum in Fault Area B Material

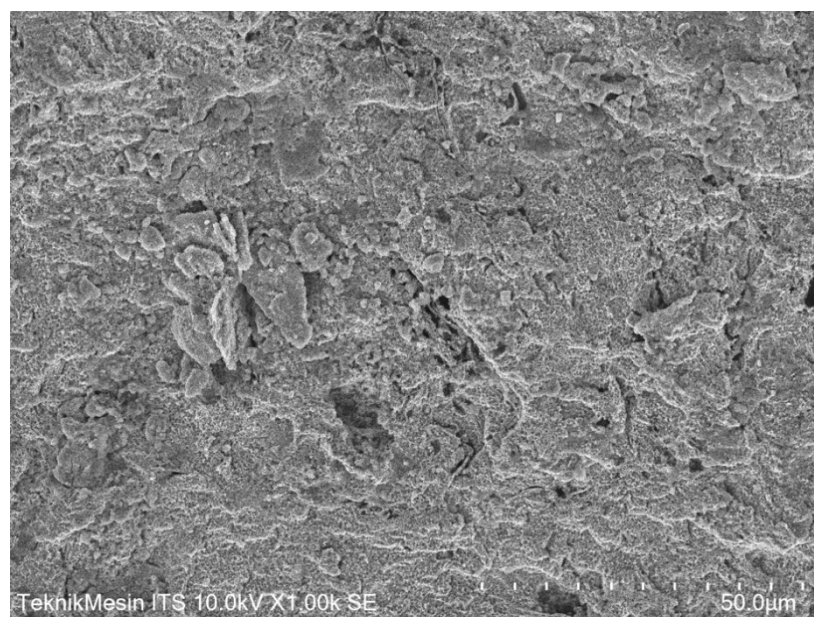
**Figure 14.** The Appearance of Micro-voids in Material B

In Material B, the presence of microvoids or localized porosity identified in the SEM images may have acted as stress-concentration sites and contributed to crack initiation. These microstructural discontinuities can accelerate crack nucleation and propagation, particularly under cyclic loading conditions associated with the operation of high-pressure SWRO pumps.
