Compliance Assessment in the Renewal of the Building Worthiness Certificate

Objective: This study aims to evaluate the compliance level of the PT X Industri building in Bandung against applicable technical and regulatory standards during the SLF renewal process, and to identify technical and administrative gaps that may hinder successful certification renewal.

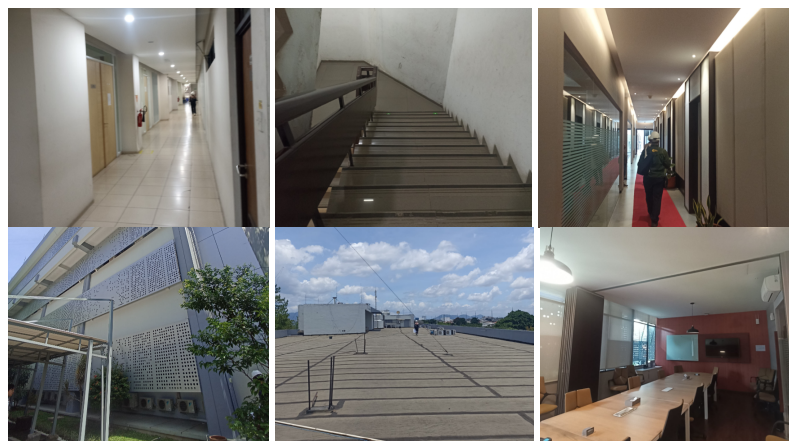
Based on the visual observation of the building, overall the building is in good condition. Figure 1 are the results of the visual inspection.

Figure 1. Visual Observation of the PT X Building

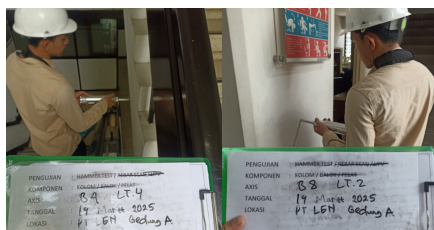
The Hammer Test is a type of test used to determine the compressive strength of the concrete surface using a concrete hammer.

Figure 2. Hammer Test Inspection
source: research data

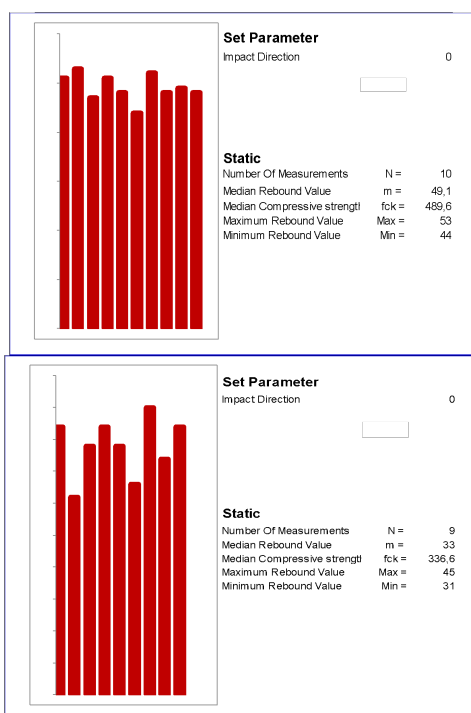
Figure 3. Sample of Hammer Test Results
source: research data

Based on the results of the hammer test on the columns, using 9 test points, the measured concrete surface hardness was equivalent to 378.53 kg/cm², with an average rebound number of 39.73. The surface hardness can be categorized as sufficient. For the slabs, using 3 test points, the concrete surface hardness obtained was equivalent to 329.80 kg/cm², with an average rebound number of 37.96, which can also be categorized as sufficient. The concrete surface hardness is classified as sufficient because it exceeds 300 kg/cm².

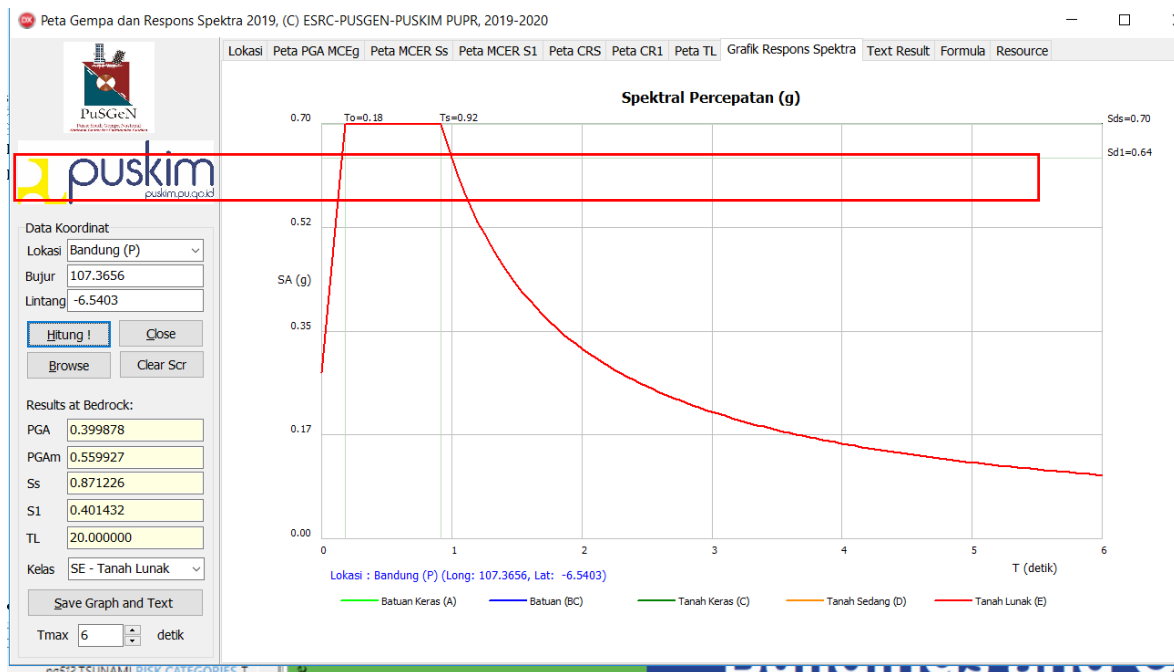
Figure 6. Bandung Design Spectrum
 source: research data

1. $S_s = 0.871226 \text{ g}$
2. $S_1 = 0.401432 \text{ g}$
3. $PGA = 0.399878 \text{ g}$
