## **Failure Mechanism Analysis of 253MA Vortex Finder in A CFB Boiler Under High-Temperature Erosion and Refractory Deposit Exposure**

**Background:** Circulating fluidized bed (CFB) boilers are widely applied in coal-fired power plants due to their fuel flexibility and low emissions. The vortex finder, a key cyclone component, separates solid particles from flue gas and is prone to wear under high-temperature, erosive conditions. **Objective:** This study aims to identify failure characteristics, analyze the causes, and explain the failure mechanism of a 253MA vortex finder in a 2 × 100 MW CFB boiler at PLTU Sebalang after 6,548 operating hours at 850–950°C.

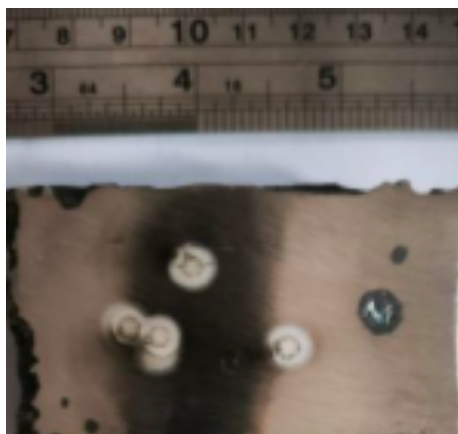
**Figure 5.** Material Sample After PMI Testing

The chemical composition of the vortex finder material was analyzed using a PMI Master Smart Oxford instrument (serial number 57T0028) with probe 66T0020. Figure 5 shows the vortex finder sample tested by PMI. Each sample was analyzed at least 3–4 times, as indicated by the white marks in Figure 5.

The analysis shows that the vortex finder material generally conforms to the characteristics of 253MA, with most elements falling within the standard specification range. Based on the test results, the Cr content was 19.8% and the Ni content was 10%; therefore, the material is categorized as an austenitic stainless steel with a typical chromium content of 16–26% and a nickel content of 10–22%.

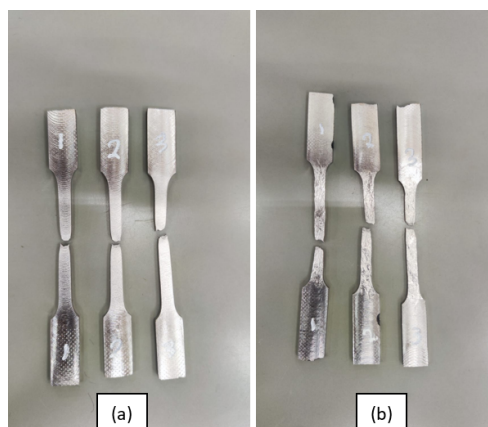
**Figure 6.** Tensile Test Specimens After Testing: (A) New Material And (B) Old Material

Tensile testing was conducted to determine the mechanical properties of the vortex finder material, particularly ultimate tensile strength, fracture elongation, and deformation behavior. The tests were performed on two types of specimens: samples taken from the installed vortex finder material exposed to operating conditions (aged material), and specimens from remaining installation material that had not been exposed to operating conditions (unexposed or new material). Figure 6 shows the vortex finder material samples after tensile strength testing.

Figure 7 shows the tensile strength of the new and old materials. The new material had a tensile strength of 723.89 MPa, while the old material had a tensile strength of 677.84 MPa. The old material experienced a 6.36% decrease in tensile strength, attributed to thermal softening due to prolonged exposure to high operating temperatures. This softening is indicated by the enlargement of austenite grains, as discussed in the microstructural observation section. Softening due to temperature exposure is also confirmed by previous research ([Triasadian et al.](#),

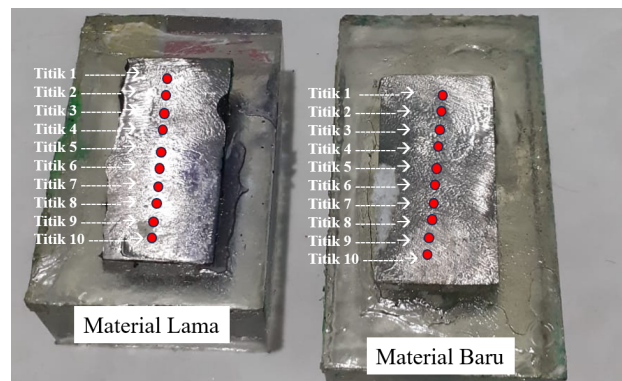
**Figure 9.** Microhardness Testing Sample.

Figure 9 shows the sample used for hardness testing. Testing was conducted at 10 measurement points to obtain a representative average hardness value. Microhardness testing was performed using the Vickers method with a 300 g load. This test aimed to determine changes

Figure 10 shows the microhardness test results. The results indicate that the new material had an average hardness value of 218.84 HV, while the used (service-exposed) material showed an average hardness value of 210.21 HV. The service-exposed material exhibited a 3.94% decrease in hardness compared with the new material. This difference indicates a measurable reduction in material hardness after exposure to operating conditions in the CFB boiler environment.

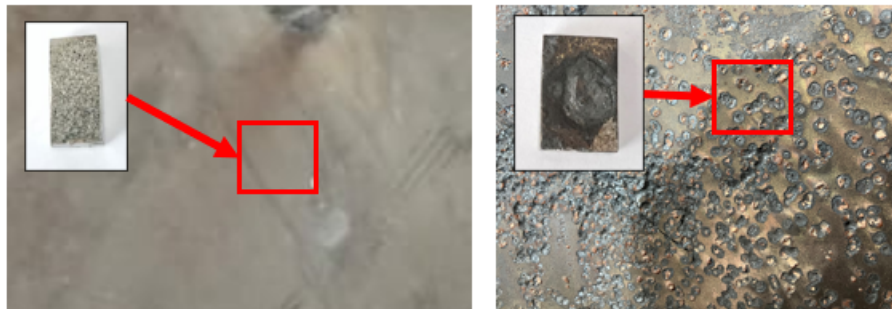
**Figure 14.** SEM-EDX Test Sample

Scanning Electron Microscopy (SEM) combined with Energy Dispersive Spectroscopy (EDS) was performed to identify the elemental composition of the vortex finder material and evaluate chemical changes after exposure to high-temperature conditions and the boiler operating environment. The analysis was conducted on two samples: the remaining installed vortex finder material (new material) and the in-service vortex finder material (old material). Figure 14 shows the area selected for SEM-EDS testing. The old material sample was taken from a region containing foreign deposits adhering to the vortex wall. The samples were tested under dry conditions, with maximum dimensions of 10 mm (diameter, length, width, and height).

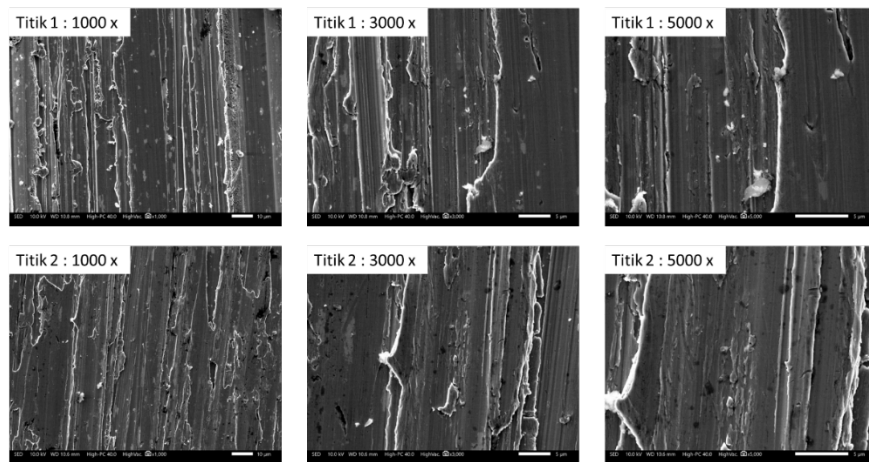
**Figure 15.** SEM Results of New Material

Figure 15 shows the Scanning Electron Microscopy (SEM) observation results for the new material. The surface morphology of the new material in Figure 5.13 is dominated by relatively uniform, elongated, and parallel lines, indicating manufacturing traces such as machining or finishing processes. These grooves have relatively shallow depth and a homogeneous distribution and do not show significant plastic deformation. Some small particles scattered across the surface are likely residual process debris or light surface contamination, but they do not form large agglomerations. In addition, no significant indications of microcracks or delamination are observed. This indicates that the material remains in a structurally stable condition, with a relatively intact surface and no degradation due to thermomechanical loading.

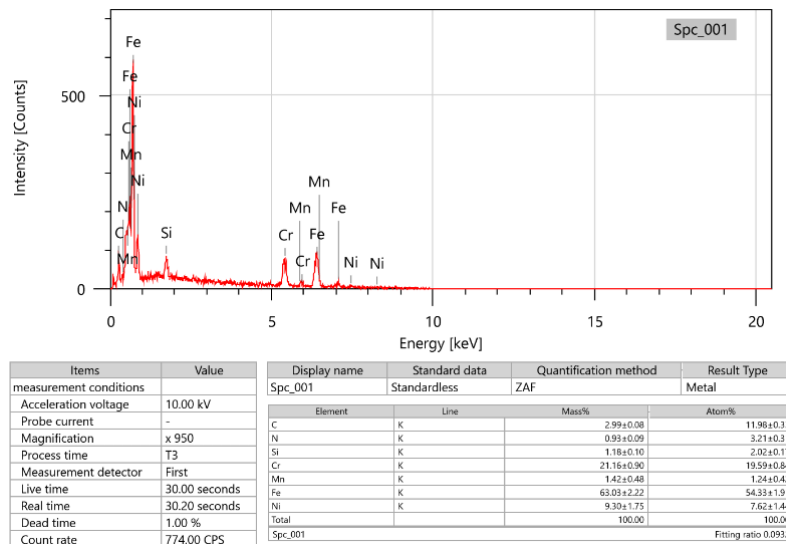
**Figure 17. SEM-EDS Test Results of New Material**

The elemental composition obtained from the EDS testing shows that the new vortex finder material has chemical composition characteristics that generally remain close to the manufacturer's 253MA material specification. This condition indicates that the new material has not experienced compositional changes due to operating conditions.

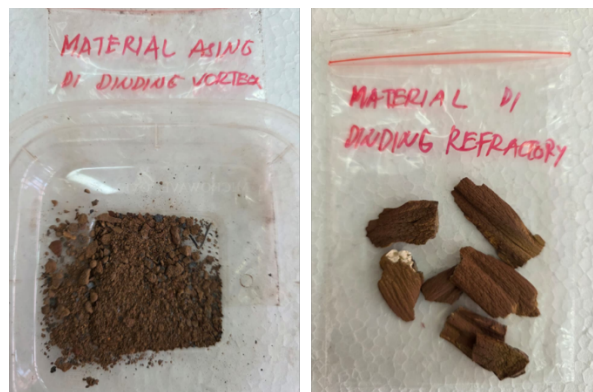
**Figure 19.** XRD Test Sample

The figure shows the sample subjected to X-ray diffraction (XRD) testing. XRD analysis was conducted on foreign material adhering to the vortex finder and on material attached to the refractory wall to identify the crystalline phases present and evaluate conformity with the refractory specifications used in the vortex finder component.

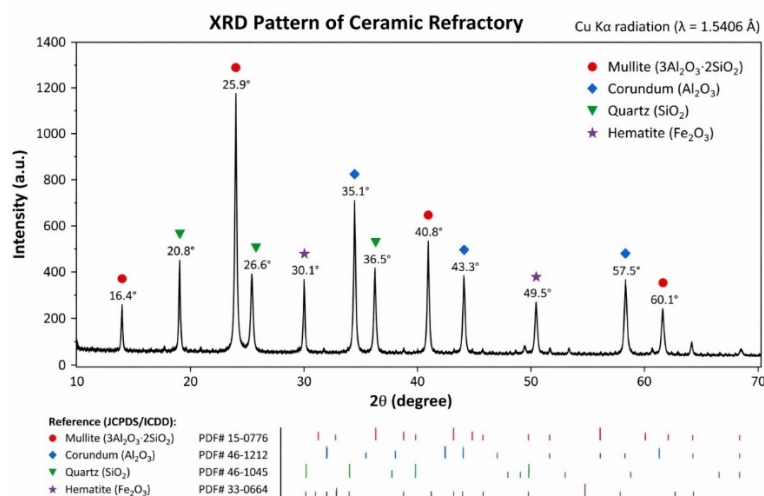
**Figure 20.** Standard International Centre for Diffraction Data (ICDD) Database

Figure 20 presents the standard International Centre for Diffraction Data (ICDD) Powder Diffraction File (PDF) database references. The analysis was conducted by matching the diffraction patterns obtained from testing with the standard International Centre for Diffraction Data (ICDD) Powder Diffraction File (PDF) database, so that each diffraction peak could be identified as a representation of a specific crystal structure.
