## **Analysis Flow Velocity and Flow Type Characterization of Noelmina River (Case Study: KM 62.3 Timor Raya Road)**

**Abstract**

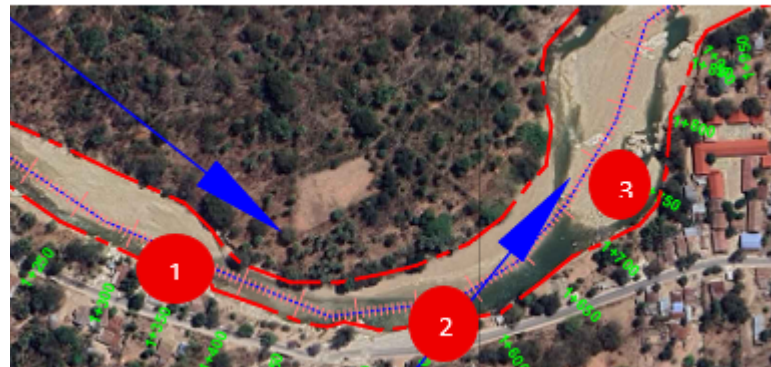
**Figure 1.** Layout of the Noelmina River and Measurement Points 1, 2, and 3

In this calculation analysis, the researcher divided the cross-section into three sections: Point 1 before the river bend, Point 2 at the river bend, and Point 3 after the river bend. One cross-section in each section was used as the reference for calculation data because it had the highest depth and velocity compared to with other cross-sections in each respective section. Mapping of the flow velocity distribution was performed on each segment of the river basin (see Table 2).
